Models Affected:
Linea - 4 GROUP
FB-70 - 4 GROUP

TECHNICAL BULLETIN #24

June 27, 2001

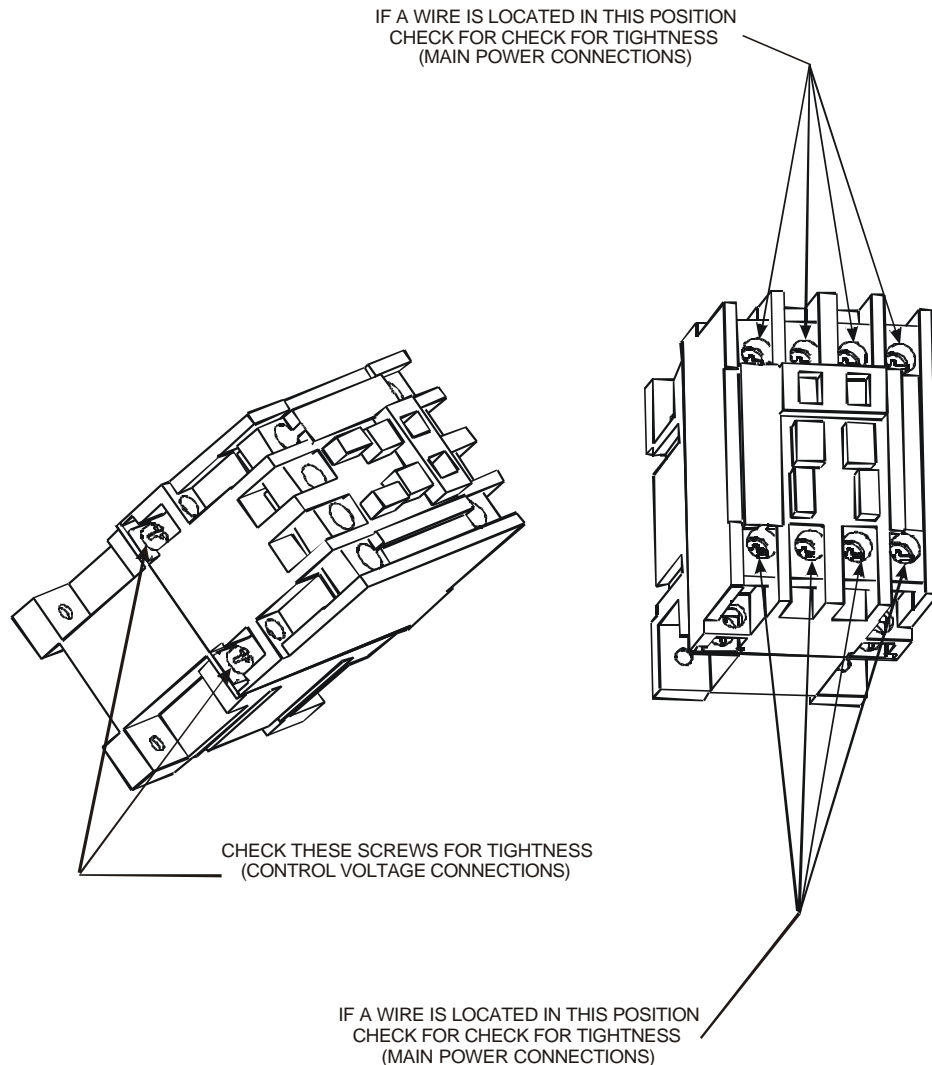
Due to vibration during shipping, the L500 contactor screws may become loose.

ACTION: All field service technicians should check to ensure that the screws on the L500 contactor are tight prior to connecting (see figure below).
