Models Affected:
Linea –ALL UL/NSF

LINEA(USA) TECHNICAL BULLETIN

January 30, 2001

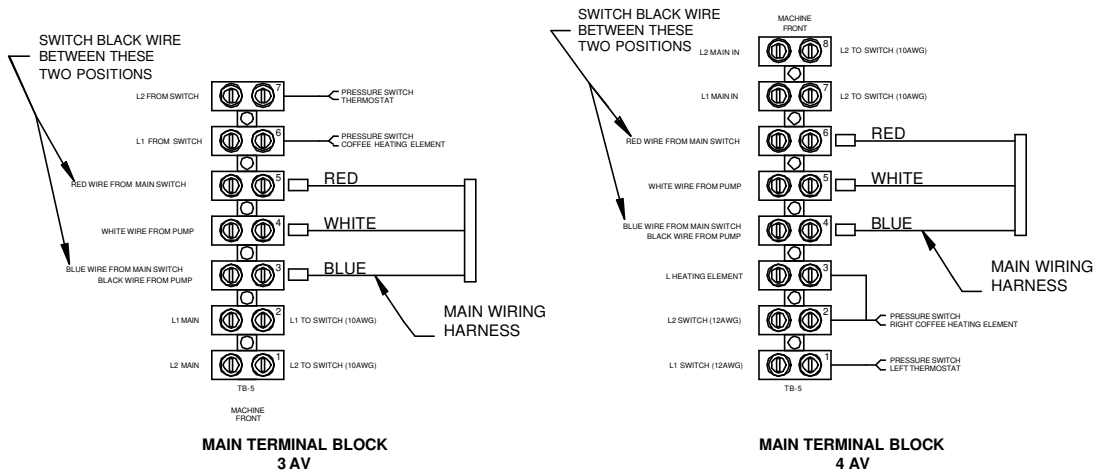
- 1) Pump Motor does not operate when brew cycle is on:
 - a. Ensure that the blue wire from the main switch is connected to the main terminal block opposite the blue wire from the main wiring harness.
 - b. Ensure that the red wire from the main switch is connected to the main terminal block opposite the red wire from the main wiring harness.
 - c. Ensure that the white wire from the pump power cord in connected to the main terminal block opposite the white wire from the main wiring harness.
 - d. The black wire from the pump power cord should be connected to the main terminal block opposite the blue wire from the main wiring harness.

If the pump motor does not operate in this wiring configuration then remove the black wire from the main terminal block and re-connect it to the main terminal block opposite the red wire from the main wiring harness.

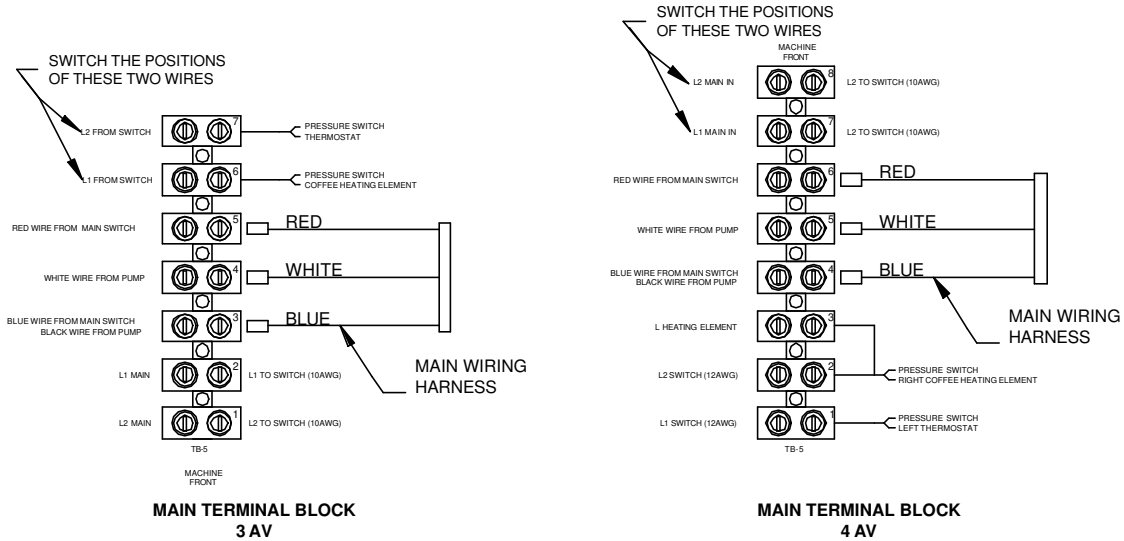
2) The heating cycle indicator lights for the coffee boilers work in reverse, i.e., the indicator light is off during the heating cycle of the coffee boiler and is lighted at the end of the heating cycle

- a. This situation indicates that the current has reversed paths. To correct this problem first locate the two white wires that travel from the main switch to the main terminal block. Switch positions of these two wires at the main terminal block. This will allow the indicator lights to operate properly.
