Models Affected:
Linea 4AV - ALL
Linea 3AV - ALL

TECHNICAL REFERENCE 110200/17

LINEA(USA) TECHNICAL BULLETIN

November 2, 2000

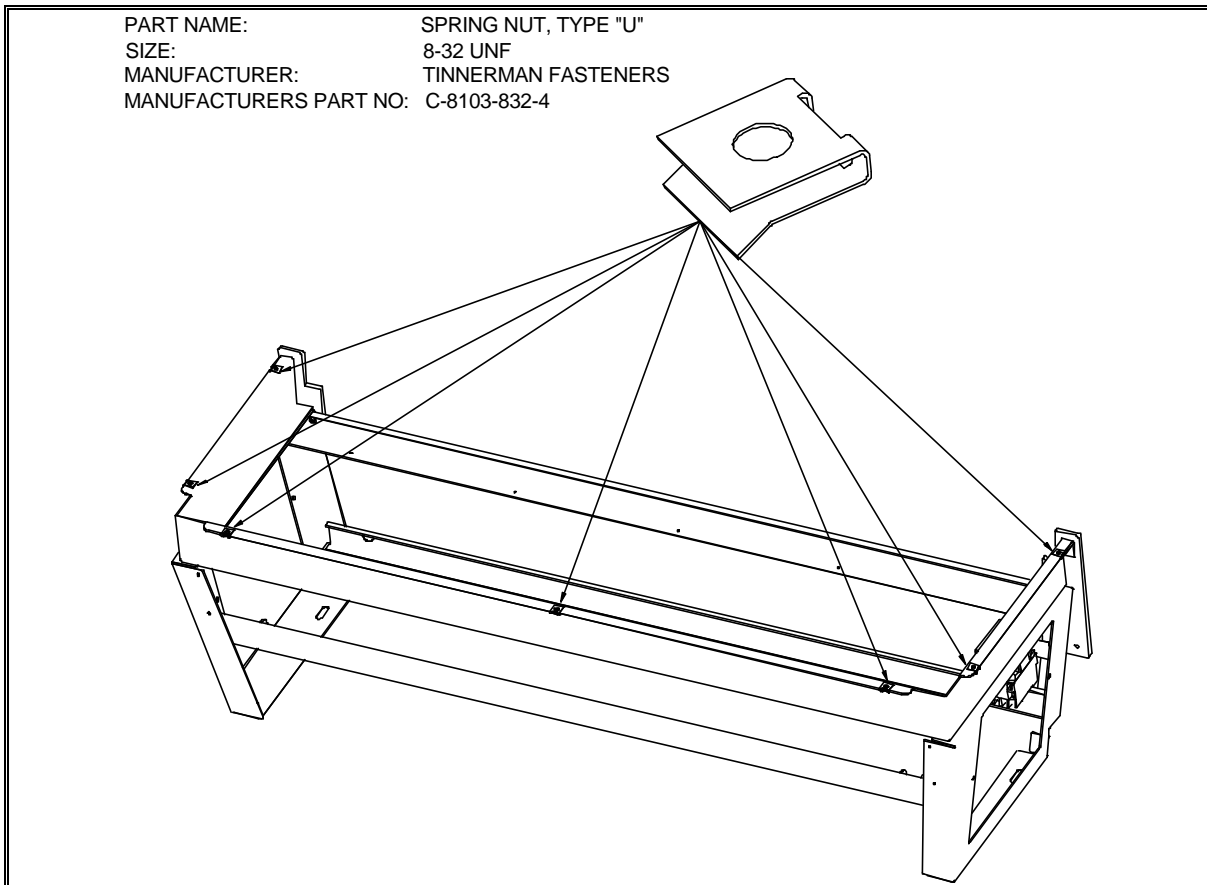
The fastening method for the Linea Surround has been changed. A spring nut has been used to replace the tapped holes as indicated in the figure below. In place of the tapped hole, a 1/4" through hole is drilled and the spring nut is installed.

La Marzocco does not recommend that modification be performed however, if a customer does wish to make this modification the vendor information appears in the figure below.
